## (OPERATION OF A HAYNES ALLOY NO. 25 FORCED CIRCULATION LOOP TO STUDY THE EFFECTS OF HYDROGEN IN A SIMULATED SUNFLOWER SYSTEM)

*by R. C. Schulze and D. B. Cooper*

NATIONAL AERONAUTICS AND SPACE ADMINISTRATION • WASHINGTON, D. C. • MAY 1965

NASA CR-225

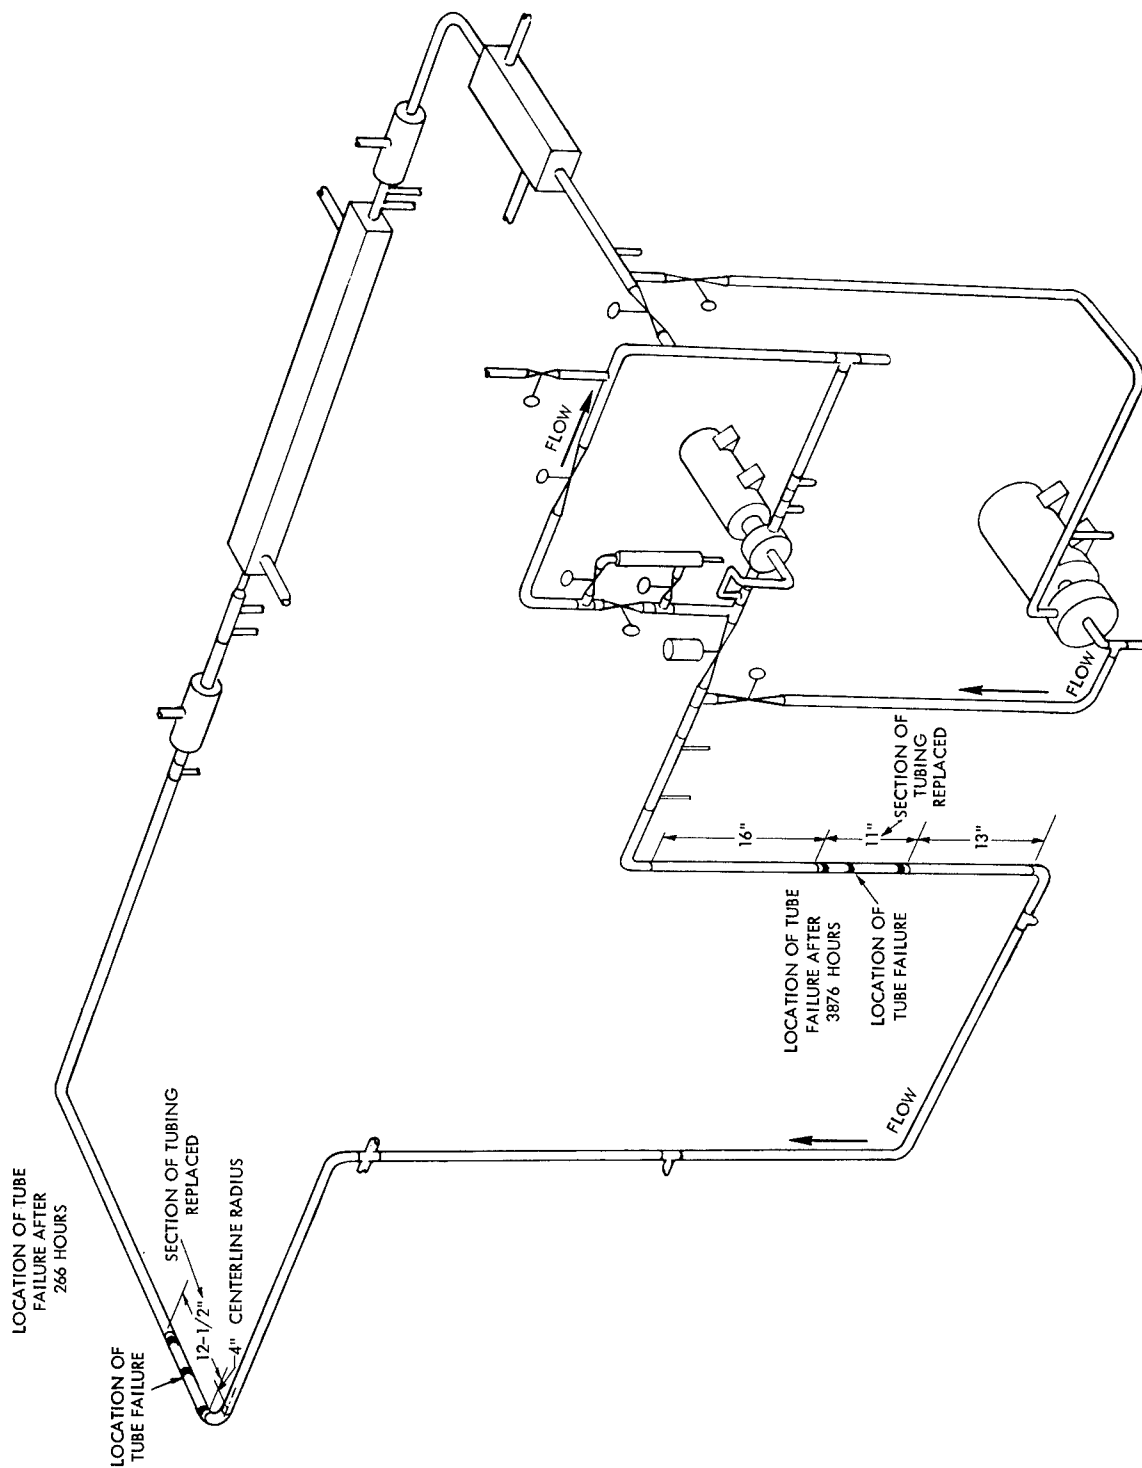
FIGURE 11 ISOMETRIC SKETCH OF THE LOOP SHOWING THE LOCATIONS OF THE TUBE FAILURES WHICH OCCURRED AFTER 266 AND 3876 HOURS

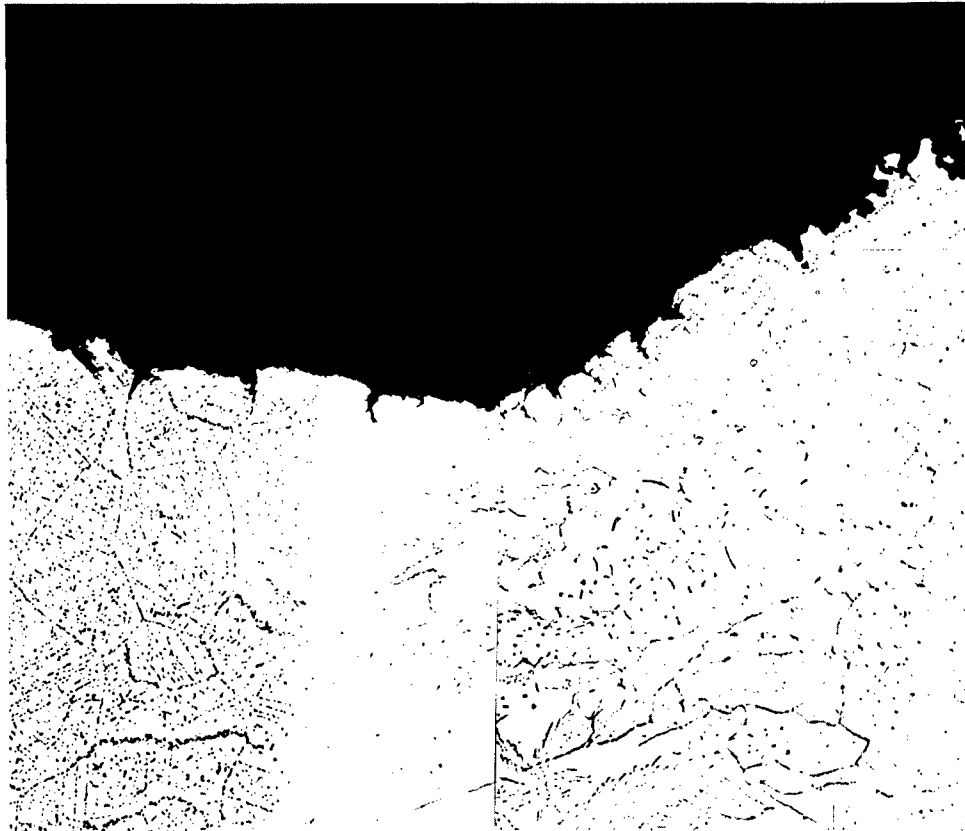
Figure 31. Appearance of Corrosive Attack Found on the I.D. Surface of the Specimen Removed from the Weld in the Lower Part of the Boiler Inlet (Section No. 11, Weld).

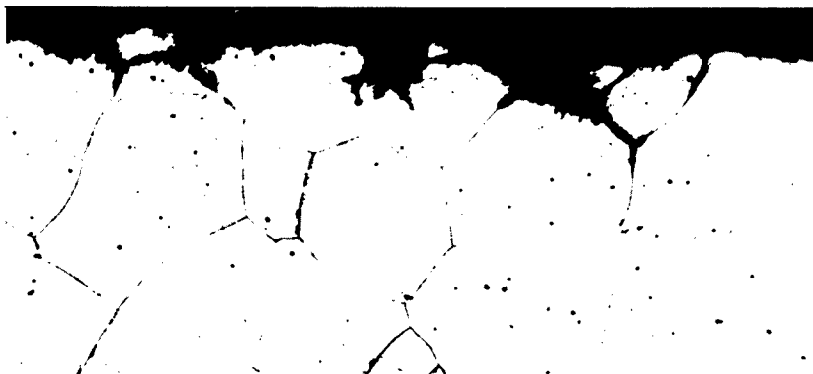
Figure 33. I.D. Surface of Specimen Removed from the Middle Region of the Boiler (Section 12, Thermocouple No. 6).

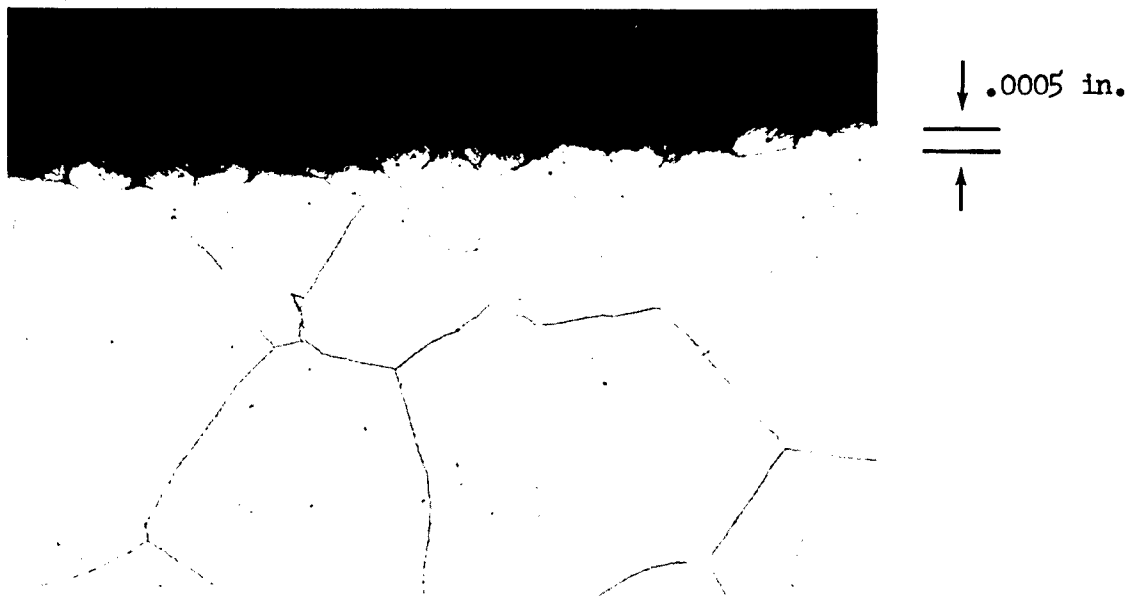
Figure 36. I.D. Surface of Specimen Removed from Superheater Inlet  
(Section No. 21, Thermocouple No. 20).

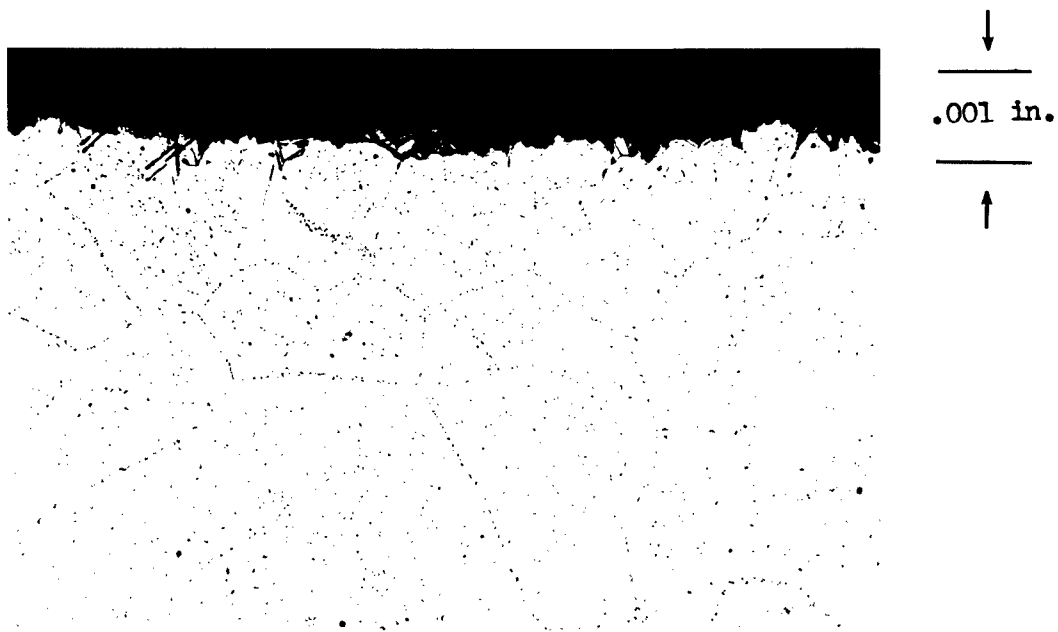
Figure 37. I.D. Surface of Specimen Removed from the Outlet Region  
of the Superheater (Section No. 26A, Thermocouple No. 24).

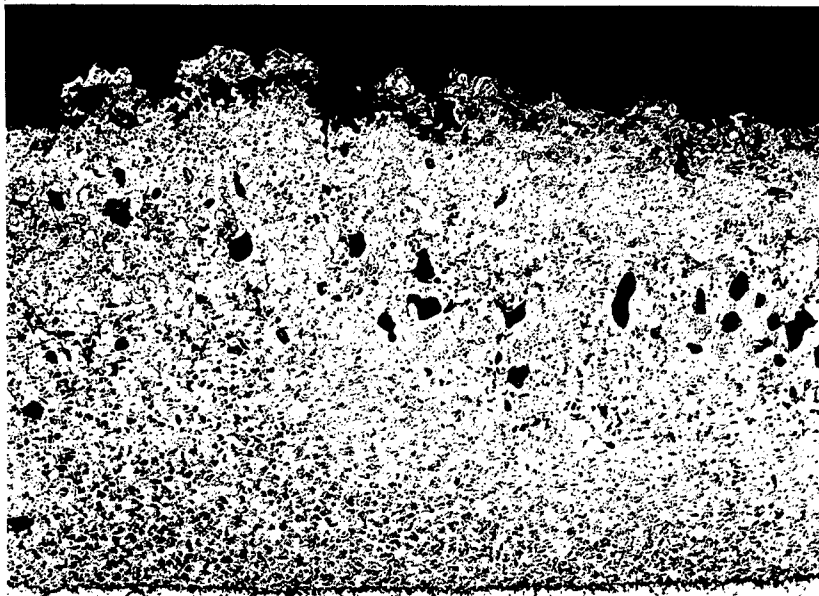
Along with the attack, deposits of corrosion products were found along the tube wall within the superheater. These deposits were metallic in appearance and appeared to be metallurgically bonded to the inside surface of the tubing. The greatest amount was found in the superheater inlet (Section 20 and 20A). Section 20A was removed after 3833 hours so that the crud separator could be installed in the superheater. Figure 38 (Section 20, thermocouple SH 1) shows the general appearance of the deposit at 100 magnification. In this region, the deposit was rather uniform in nature as shown in Figure 39 (macrograph of a portion of Section 20). The thickness of the deposit varied from 0 to .03 in. in depth.

Figure 38. Appearance of Deposit Found on the I.D. Surface of the Specimen Removed from the Superheater Inlet (Section 20, Thermocouple No. SH 1).

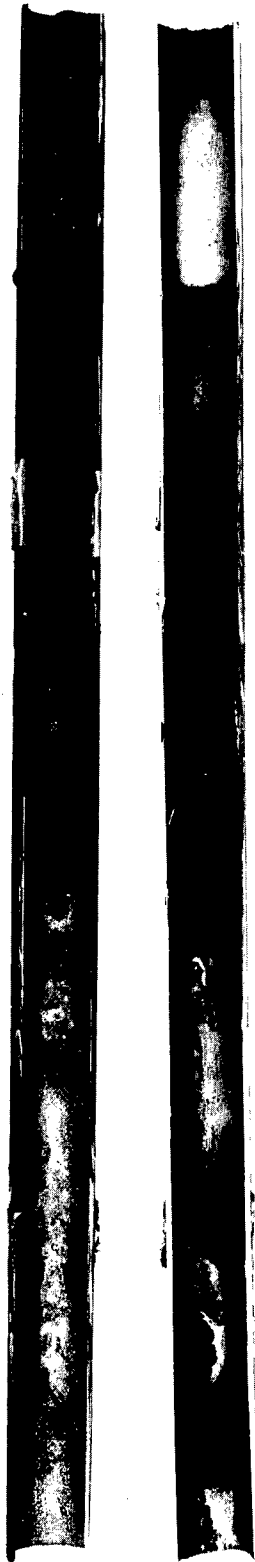
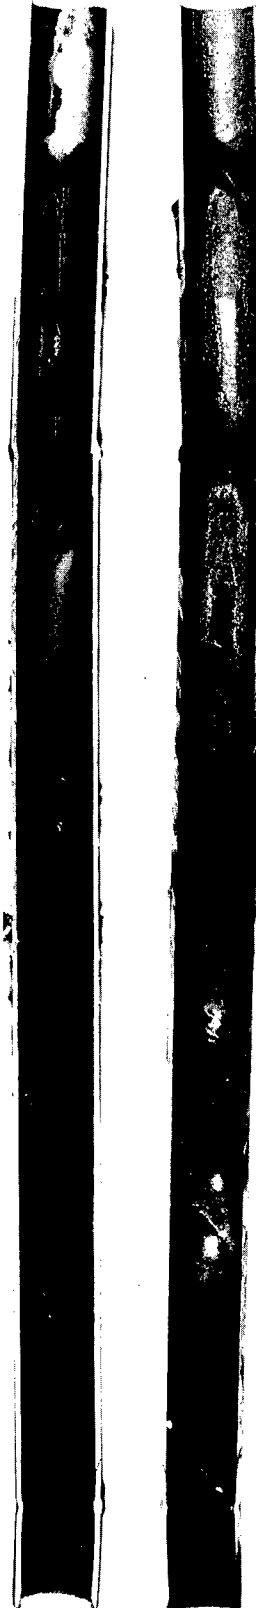
Figure 40. Macrograph of the I.D. Surfaces of the Sections Removed from the Middle Region of the Superheater (Section Nos. 22 and 23).

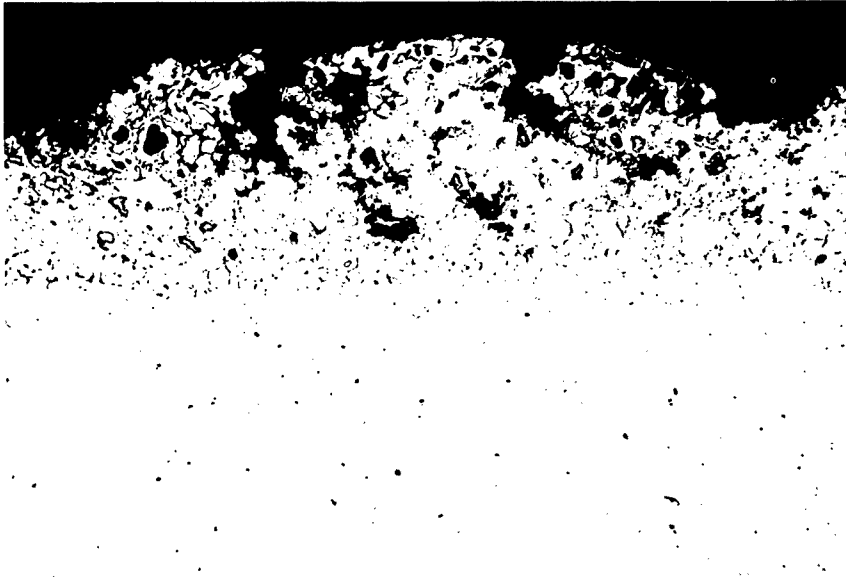
Figure 41. Appearance of Deposit Found Along the I.D. Surface of the Specimen Removed from the Middle Region of the Superheater (Section No. 22, Thermocouple No. 22).

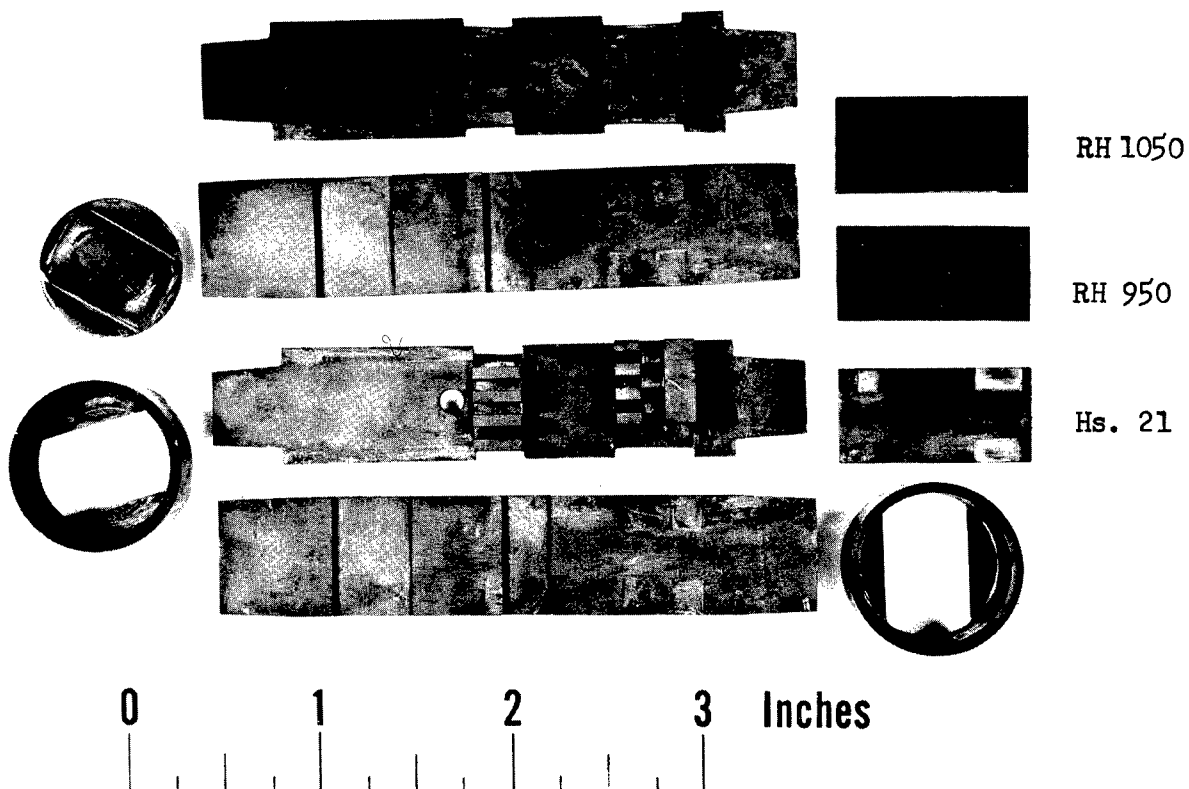
Figure 50. Appearance of Orifice and Specimen Holder Assembly After Test. Actual size.

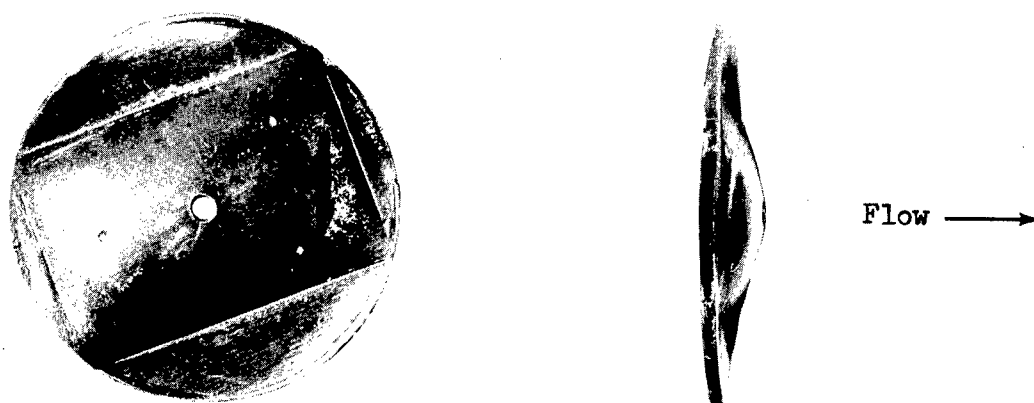
Figure 51. Macrograph of the Orifice Plate Showing the Amount of Distortion Incurred. Mag. 2.6X

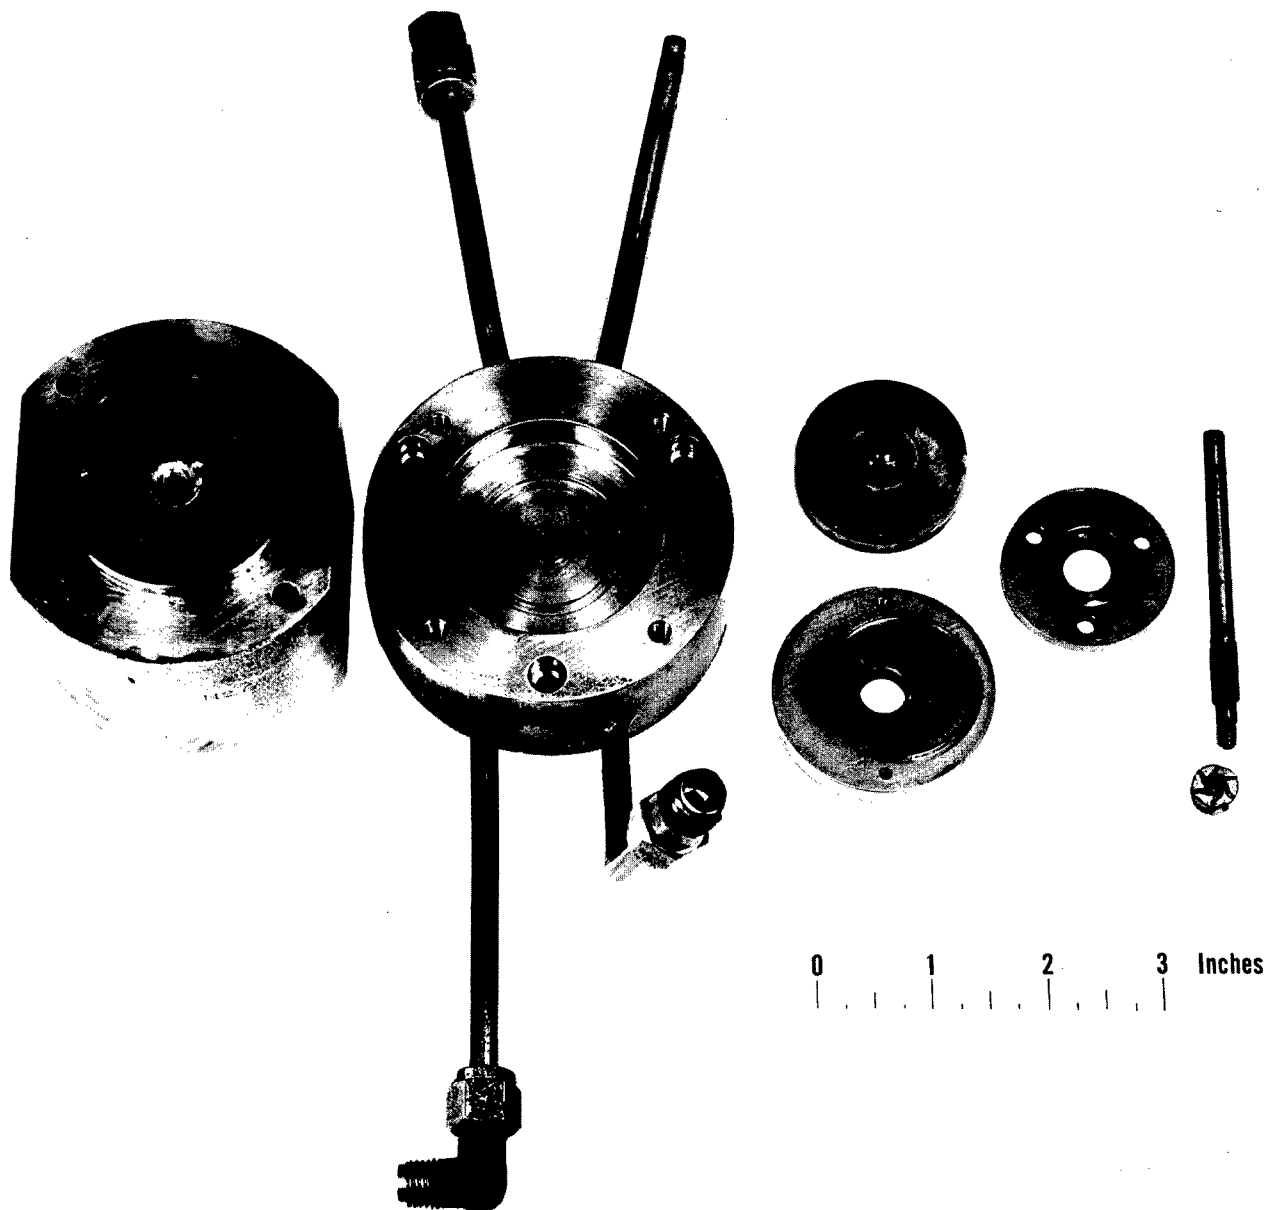
The centrifugal pump was operated for approximately 1000 hours, during these tests. The only area of the pump that was damaged during test was the volute tongue where an erosive action had occurred.

Figure 55. Condition of Centrifugal Pump Components After Test.  
Size of components reduced to three-quarters original size.

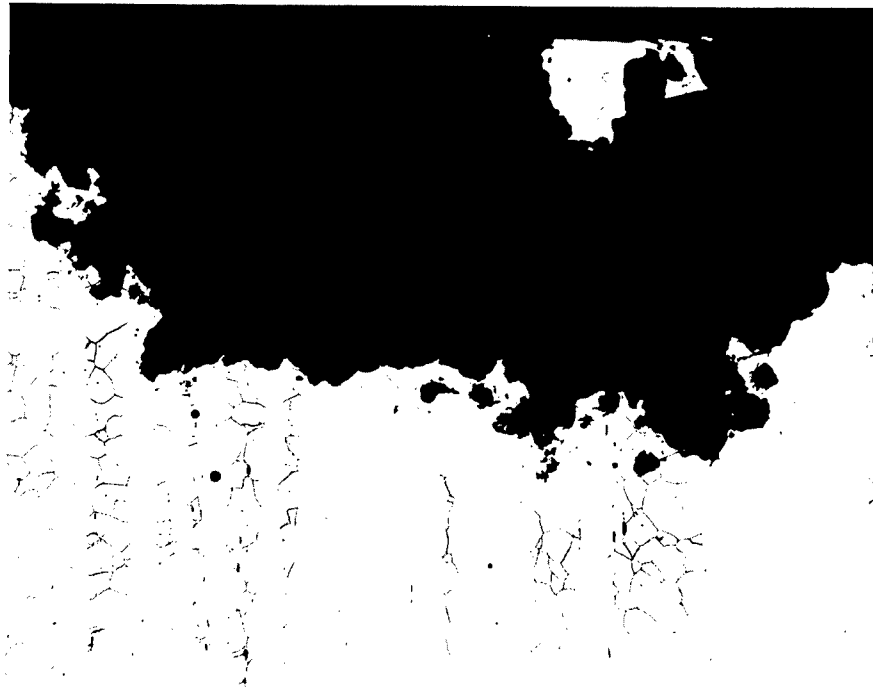
Figure 57. Appearance of the Damage Incurred Around the Volute Tongue. Specimen removed from the top half of the pump body which was fabricated from Type 316 Stainless Steel.

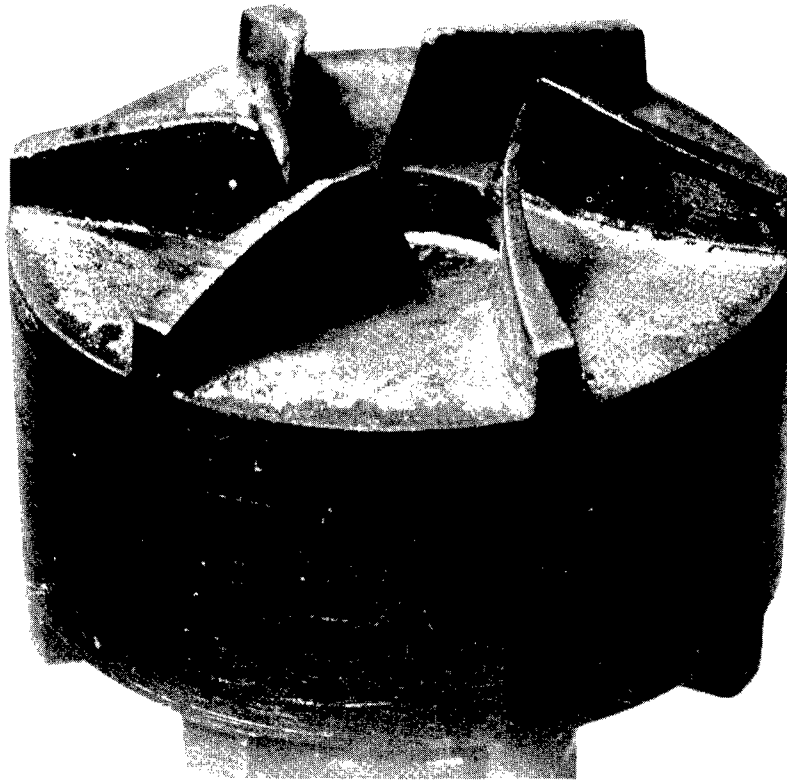
Figure 58. Macrographs of the Centrifugal Pump Impeller Showing the After Test Condition. Impeller was fabricated of Type 316 Stainless Steel.

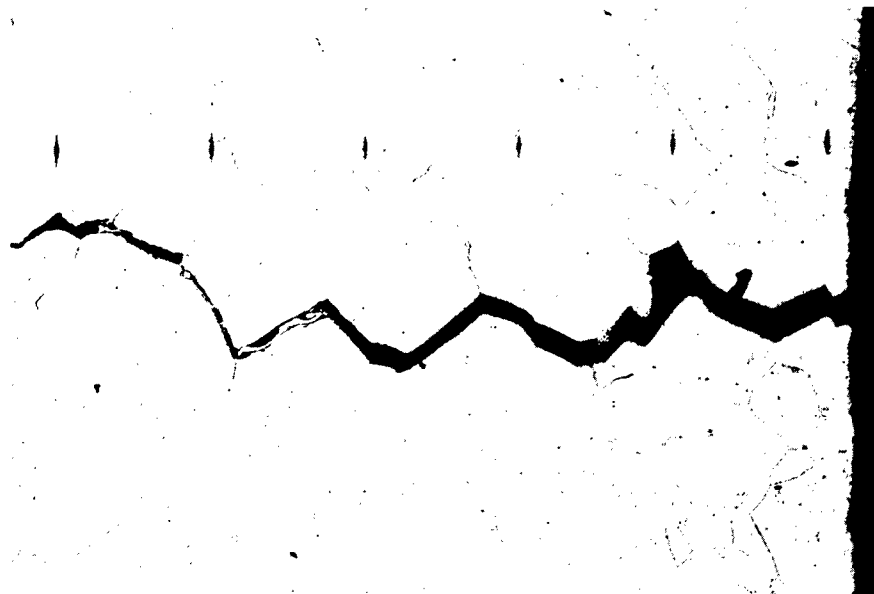
Figure 59. Appearance of the Crack Found in the Tube Wall of the Superheater After 262 Hours of Operation.

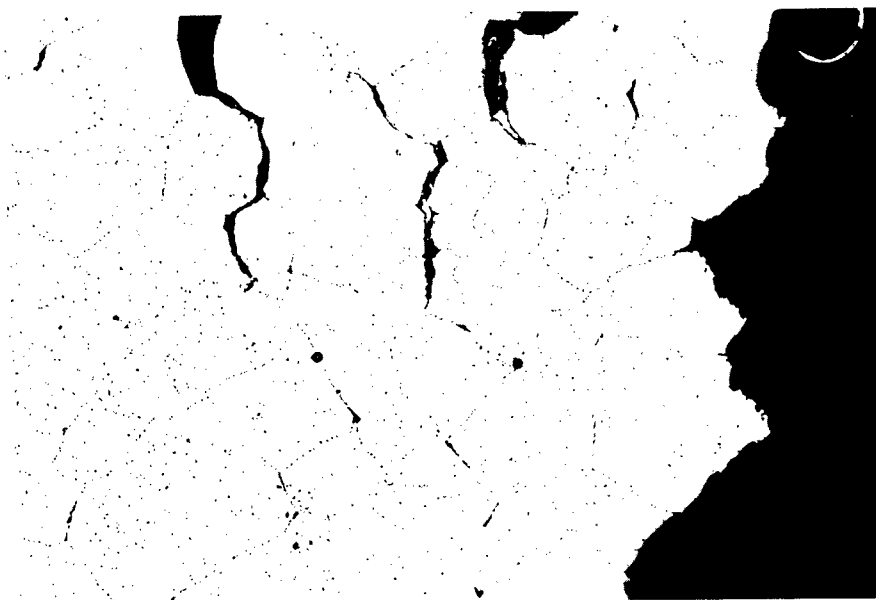
Figure 61. Appearance of the Tube Wall of the Boiler Showing the Failure which Occurred After 3876 Hours.

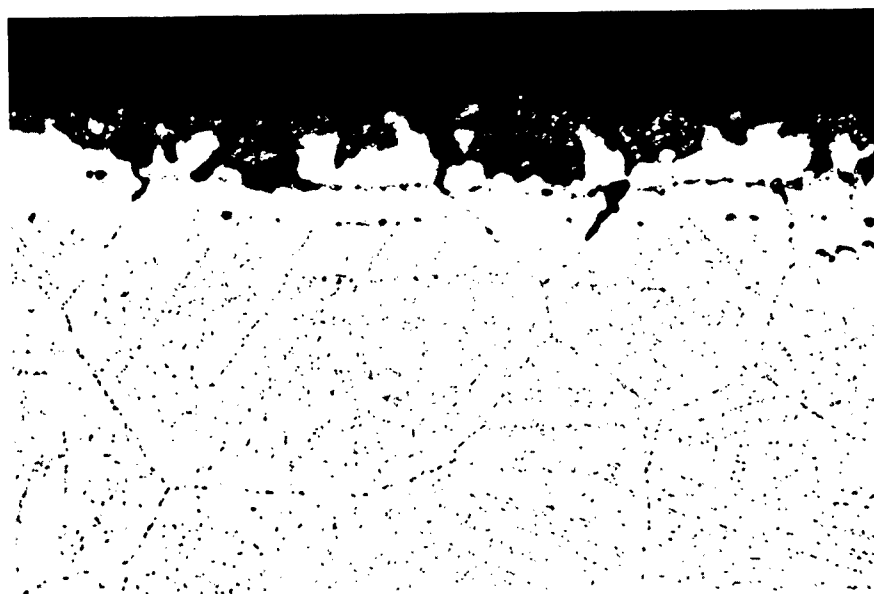
Figure 62. Appearance of the I.D. Surface Near the Failure which Occurred in the Boiler After 3876 Hours.
